Highway Facility Study

Jefferson County Highway Department

Jefferson County, Wisconsin

July 2008

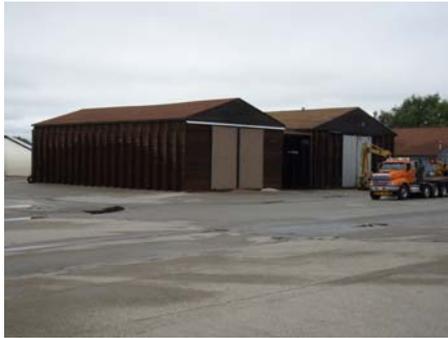
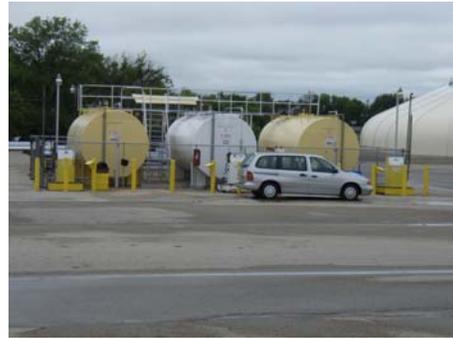
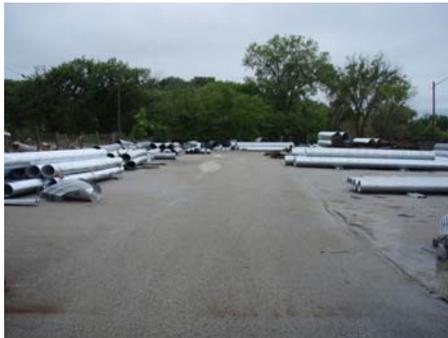
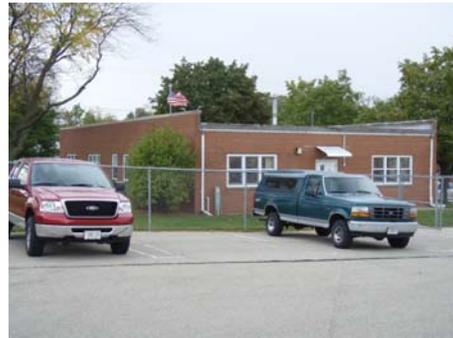
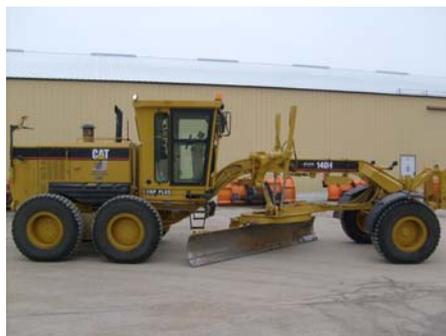
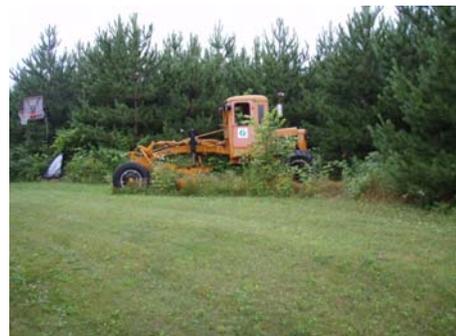
Because the intent of this study is to identify the cost/benefit aspects associated with the past study and the current conditions, SEH will refer in general terms to the condition of the “building systems” – the Architectural, Structural, HVAC, Plumbing, and Electrical packages. We will also provide commentary on Security – a sixth system now prevalent in Highway and Public Works facilities. During our first visit of the facilities we found the compound to be neat and appeared to be well-maintained. At-a-glance, it would appear that as neat and clean as the facilities are, there would be no need for a major project improvement; that any changes required would be mostly cosmetic in nature. This however, is not the case. Evidence of this can be found in the two photos below. Photo A is that of a 2003 Caterpillar 140H. Photo “B” is that of a 1958 Galion Motor Grader. Both photos were taken 30’ - 0” away from the respective piece of equipment. This is a case in point why the Highway Department needs an upgrade. Modern day equipment is larger, requires dozens of gallons of hydraulic fluids and oils, is loaded with electronics and can have (9) on board computers. Having a neat facility may help with safety and have some small functional efficiency, but it doesn’t mean much if the hydraulics are frozen and can’t be worked on inside in a timely manner.

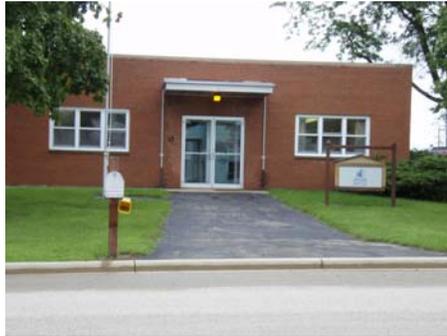
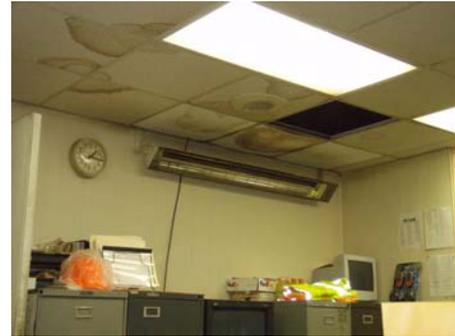
In our visits, SEH found that the Architectural and HVAC issues have gotten worse since the 2000 Study. Architecturally, roof leaks have become common place in the existing Repair/Vehicle Storage Building. The single pane windows and the uninsulated wall systems (as applicable) in the heated buildings continue to emit energy inefficiencies, almost exponentially as energy fuel costs continue to climb.

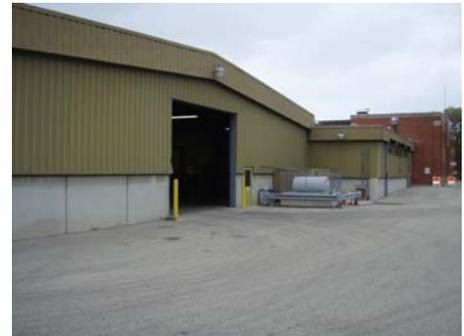
The older heated Vehicle Storage Facility has witnessed seven years of additional wear. Architecturally, further degradation of the metal wall panels will continue, however, the uninsulated concrete push walls pose the larger problem of a thermal “nose bleed” in this era of hiked energy costs. With the lapped-seam metal roof, expansion and contraction of the metal panels will continue to shield from water infiltration. It should be noted that this building, when replaced is quite possibly more valuable today than what it was purchased. Recycled metals, including steel, are bringing record prices. This particular building has paid the County back repeatedly in the course of its life.

The HVAC system has witnessed its normal period of useful life. The radiant heating system is common, relatively efficient, easy to maintain, and easily replaced, should that choice be made. Of more concern is the plumbing system, particularly the underground systems. The 2000 study makes reference to not being able to determine where the underground sanitary leaves the building. This should be considered important priority. At some point, it should be determined and corrective actions taken if necessary.

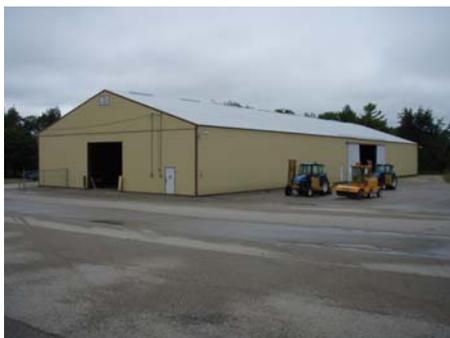
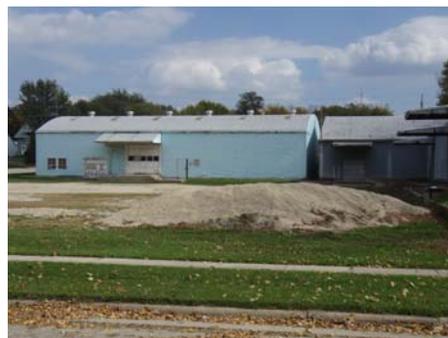
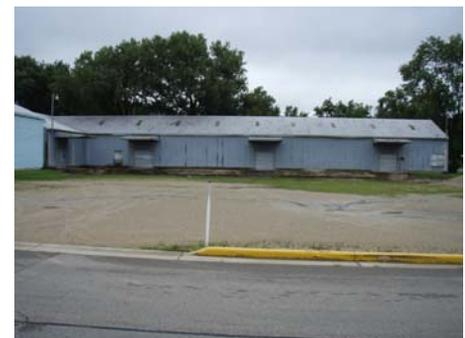
These buildings are of two different vintages – one a “late” model agricultural pole building and two more standard wood frame buildings near 50 years old. While the post/frame building has served its purpose, it by no means, currently meets the Commercial Building Code. The structure is designed as an agricultural building only. It should be used in a private setting and not in commercial applications, particularly in an urban setting. The other two buildings have had the metal skin painted over the years. All doors and windows are in need of upgrade if the building will continue to be used by the Highway Department in the long-term future. This would be specifically addressed as a security issue.
